Revival of the Matilija Sanctuary Health Spa

By
Tyler Erickson

Revival of the Matilija Hot Springs Health Spa, a conceptual redesign of an early 20th century "Health Spa" which will serve as an interpretive / educational center informing visitors of the historical and environmental significance of the site.

A Senior Project / Thesis
Presented to the Faculty of the
Landscape Architecture Program
University of California, Davis
in Partial Fulfillment of the Requirement
for the Degree of
Bachelors of Science of Landscape Architecture

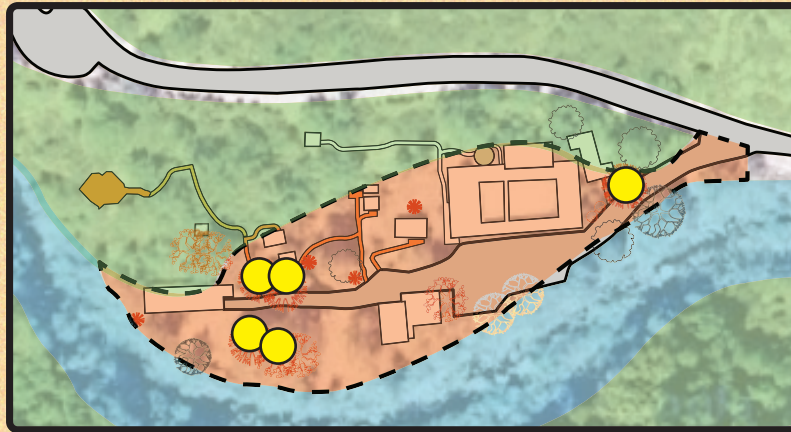
Fig. #52

Non-native plantings are most heavily concentrated along the northern, uphill side of the Park Landscape Area. With exception to the trees identified above all non-native landscaping will be removed and replaced with a native planting palette.

The Park Landscape area is the region of the hot springs that served as the main grounds of the resort. Around the late 1930s the then owner of the property began introducing exotic trees and plants to the resort in an attempt to create a more tropical atmosphere. This was a common trend among health spring resorts in California.

One major goal of the intervention is to return the site as closer to the native habitat, but at the same time it is important to maintain the character and integrity of the historic resort.

In 2012 an arborist report was completed which evaluated the condition of older trees on the property that may be of historic value. 15 trees were evaluated and rated. Using this information and considering the placement of the trees on site the trees to remain were identified.

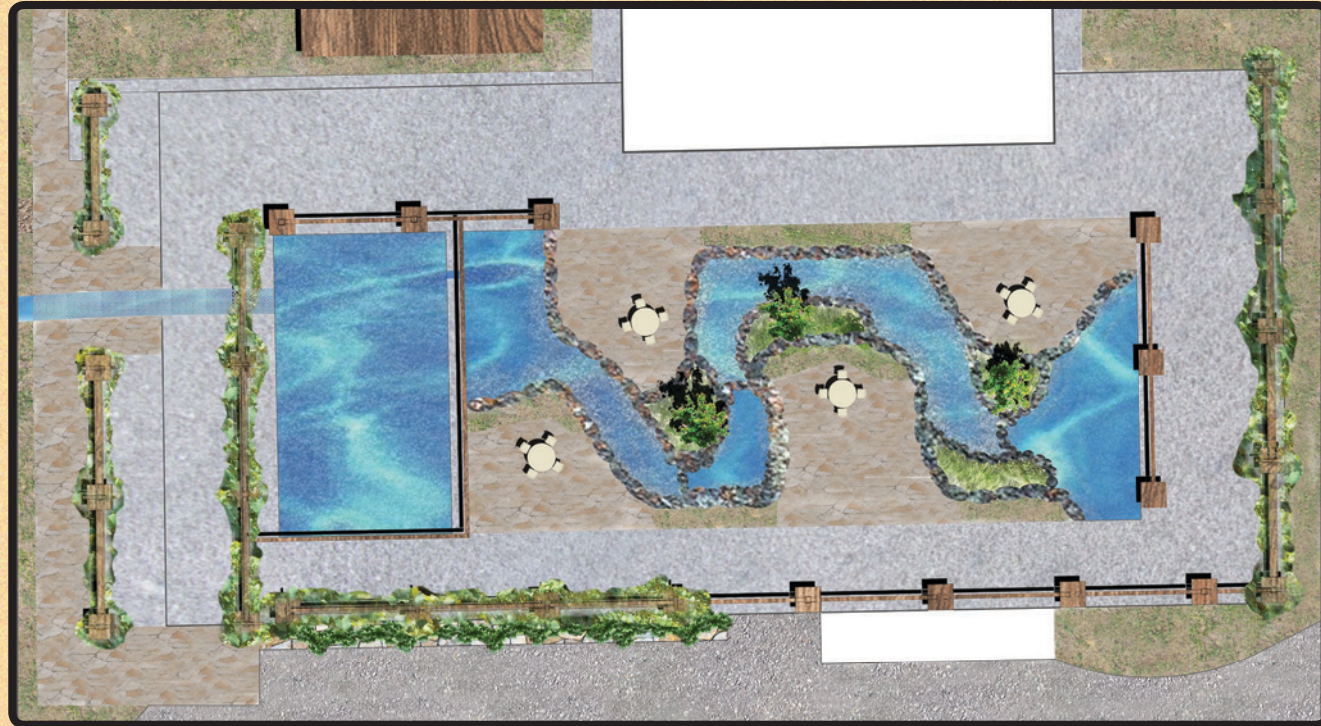
Fig. #56

This plunge / pool is the oldest landmarked pool in California being built in 1902. The pool has not been filled since 1987 when the property went from county to private ownership. The decking surrounding the pool is deteriorating in certain areas and it was estimated by a pool specialist within the last two years that to bring the pool to working condition it would cost over \$3 million, which is a price tag the county cannot afford. A main factor in this steep figure is the pool has always drained directly into the nearby creek and would require an entirely new³³
